Neponset River Dredge Spoils Assessment Boston and Milton

Executive Office of Energy and Environmental Affairs (EOEEA)
Department of Environmental Protection (MassDEP)
Department of Conservation and Recreation (DCR)

Prepared by MassDEP, DCR & MACTEC Engineering & Consulting, Inc.
Contractor to MassDEP

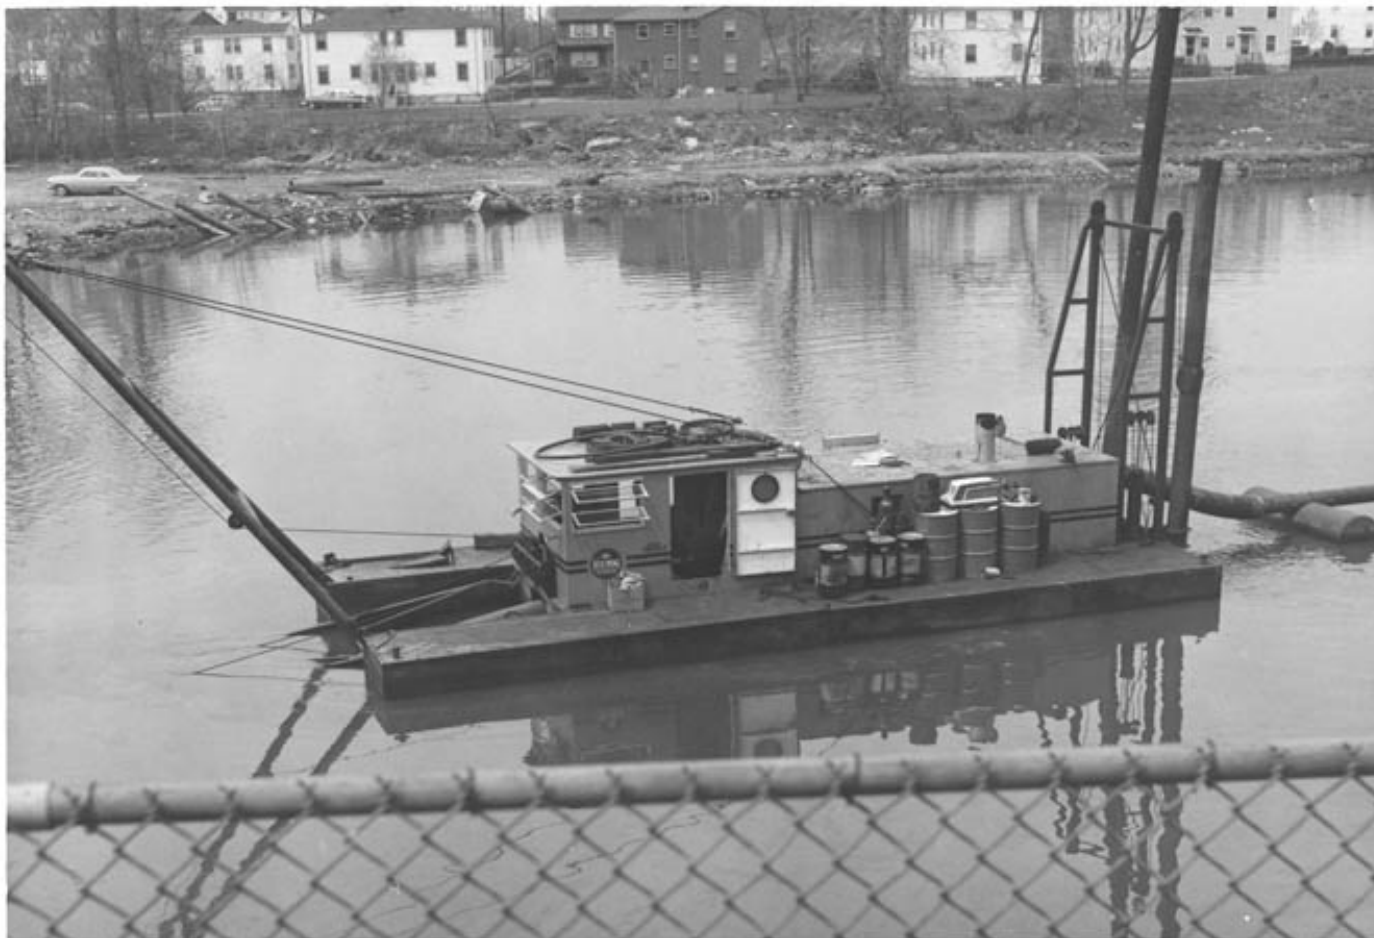
Dredging Barge

DIXIE" portable dredge - Looking N'ly from sta. 39+00 left -
Neponset River Flood Control - -C294 - 5/7/64 - Photo Barbier -
C294-89

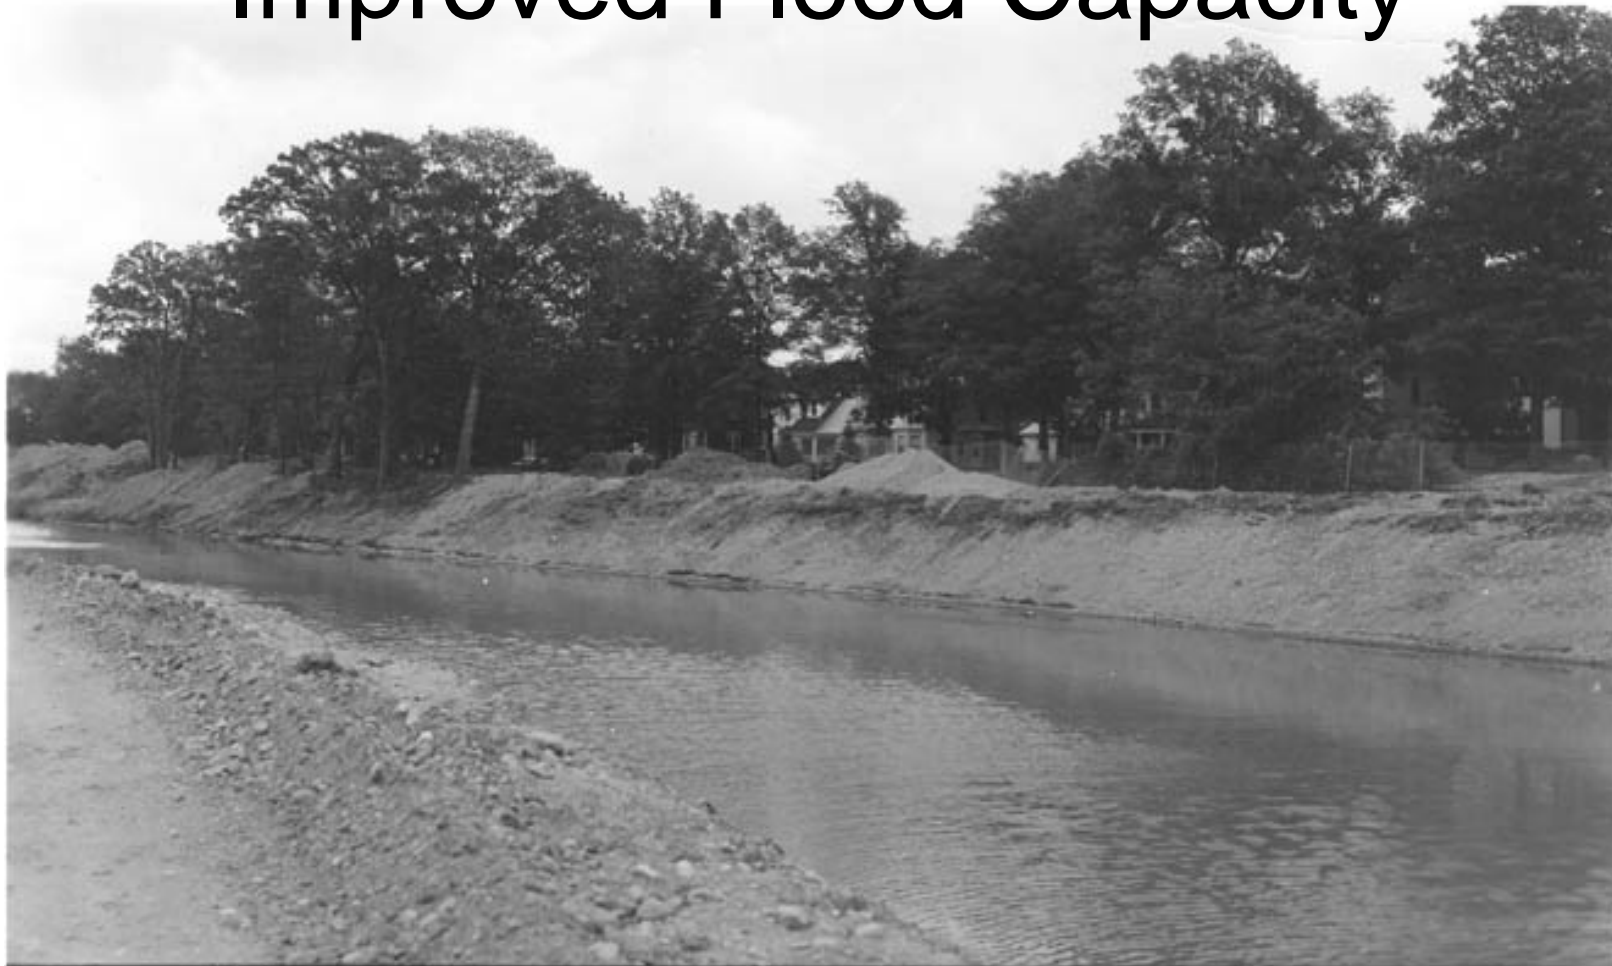
Deepened River Channel for Improved Flood Capacity

Looking NE'ly from sta. 117+60± - Neponset River Flood Control
C294 - 6/20/63 - Photo Barbier - C294-41

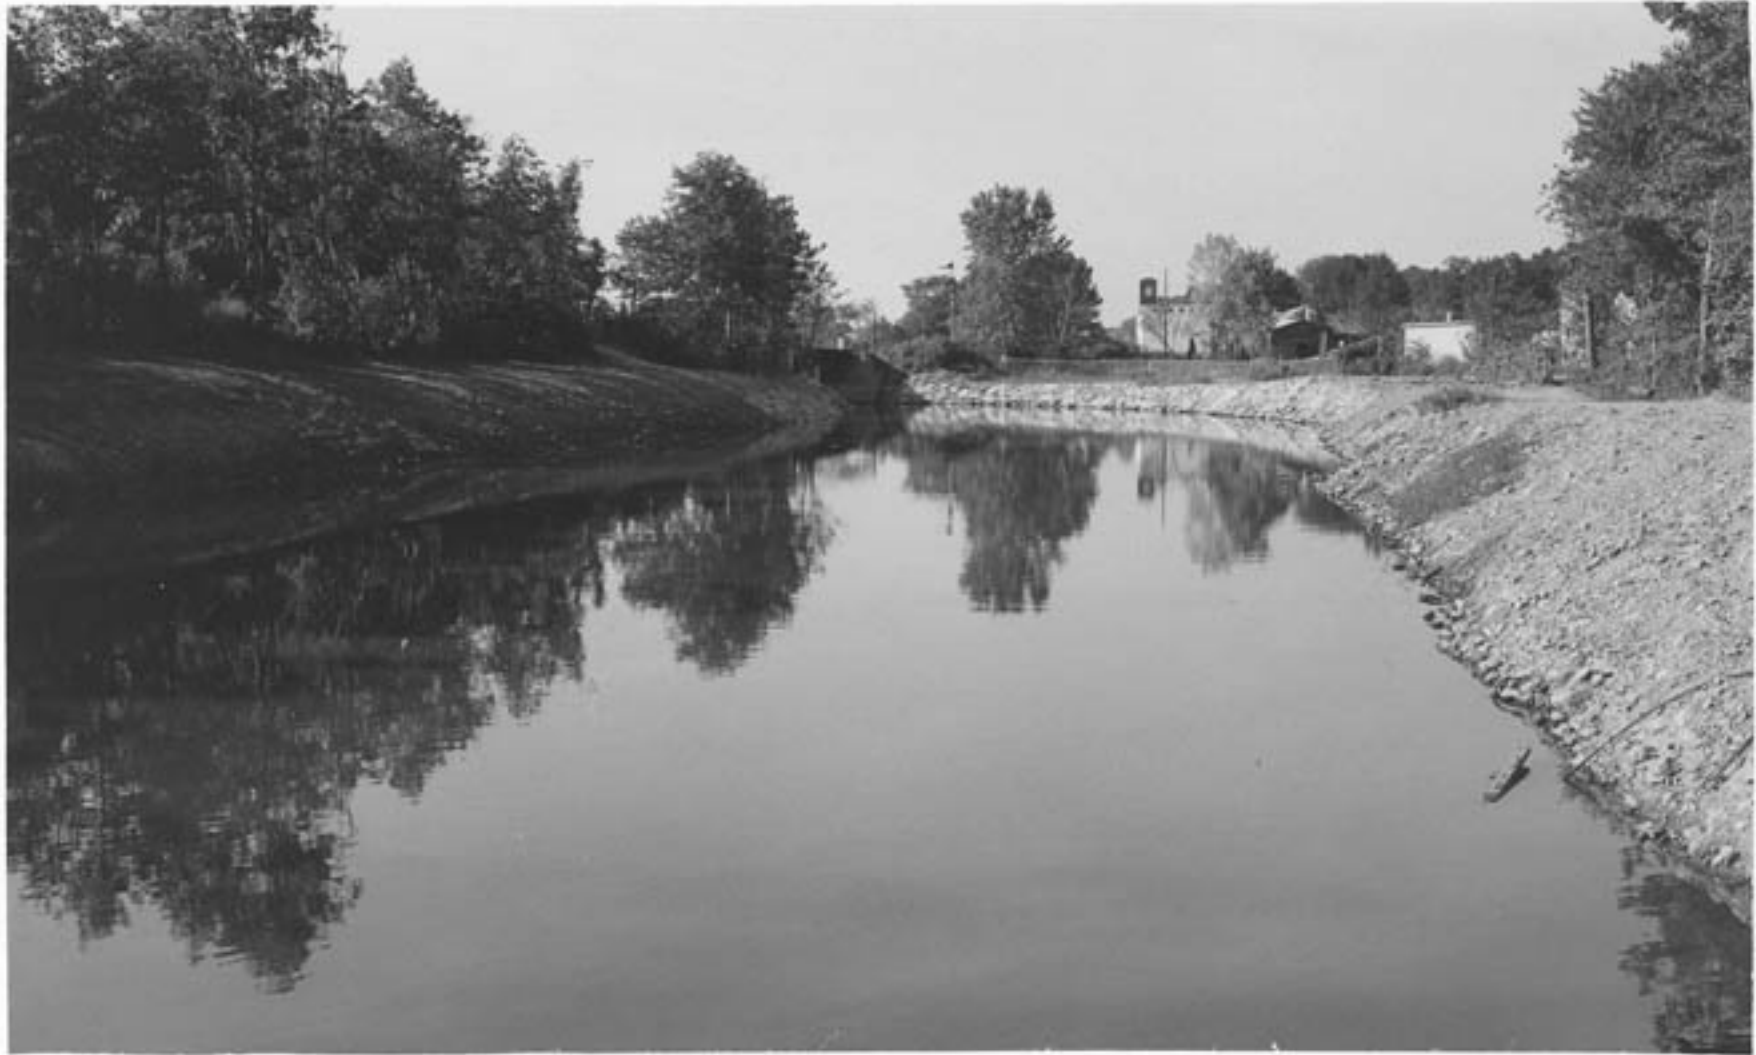
Reinforced River Banks

S'W'ly, near sta 156+00--Neponset River F.C.--C296--9/28/67
Photo Maley C296--145

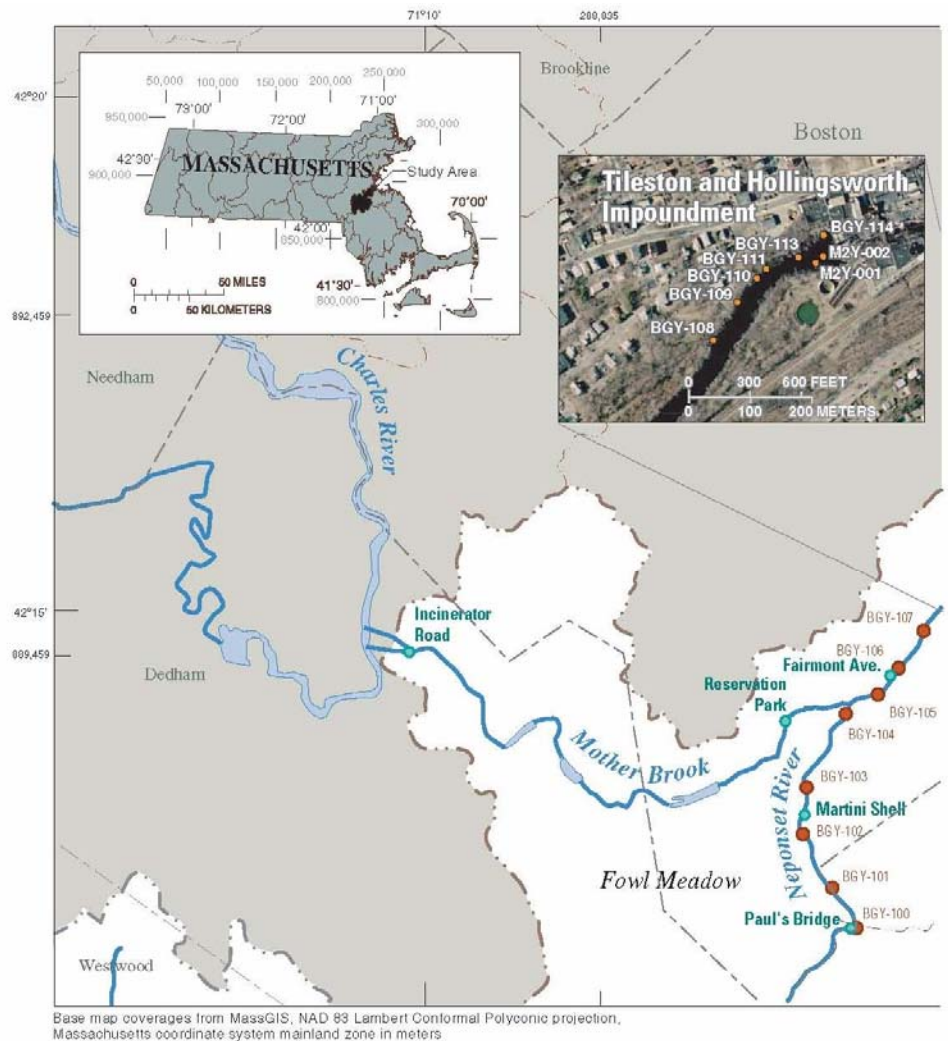
USGS Study

- In 2002 and 2003 USGS collected samples from the Neponset River:
 - 20 grab sediment (top 4")
 - 31 sediment core (5"-50")
 - 12 surface water
- Samples were analyzed for metals, pesticides, petroleum, and PCBs

- “Although enriched relative to background, most constituent concentrations were equal to or less than those found in other urban rivers, with the notable exception of PCBs.”
- Range of Neponset PCB concentrations:
 - In grab sediment samples: <1.4 – 11 ppm
 - In sediment core samples: <1 – ~225 ppm
 - Typical urban sediments: <1 ppm

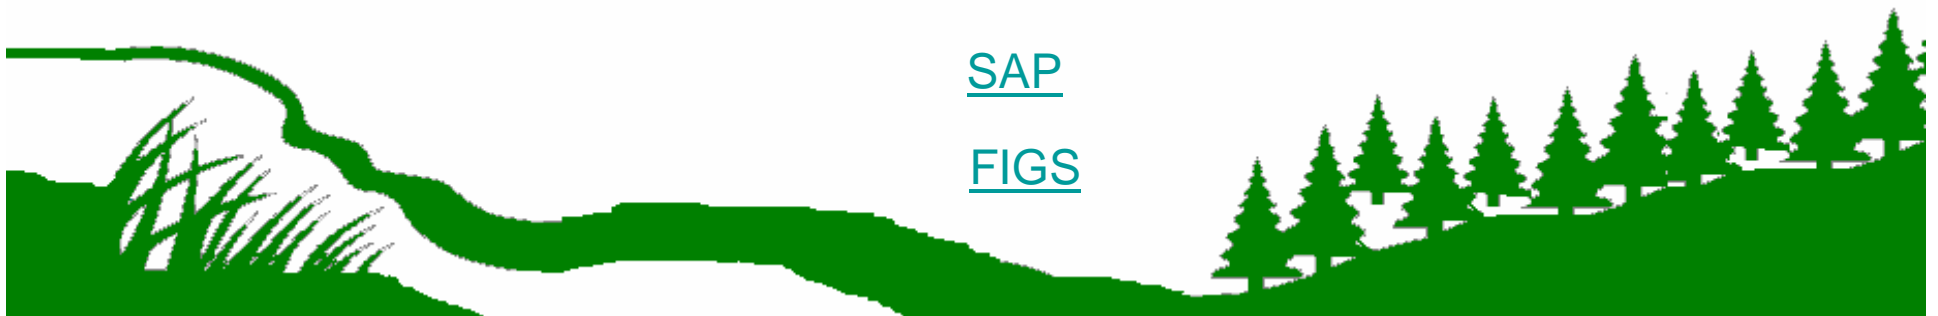
Sampling Plan Overview

- Up to 200 surface soil samples from 100 locations, depth intervals of 0"-6" and 6"-12".
- Samples from pathways and at canoe launches and other actively used areas.
- Samples will be tested for PCBs; 20% will also be tested for 13 metals.
- Five sediment samples at canoe launches at 0"-6" will be tested for PCBs and metals.

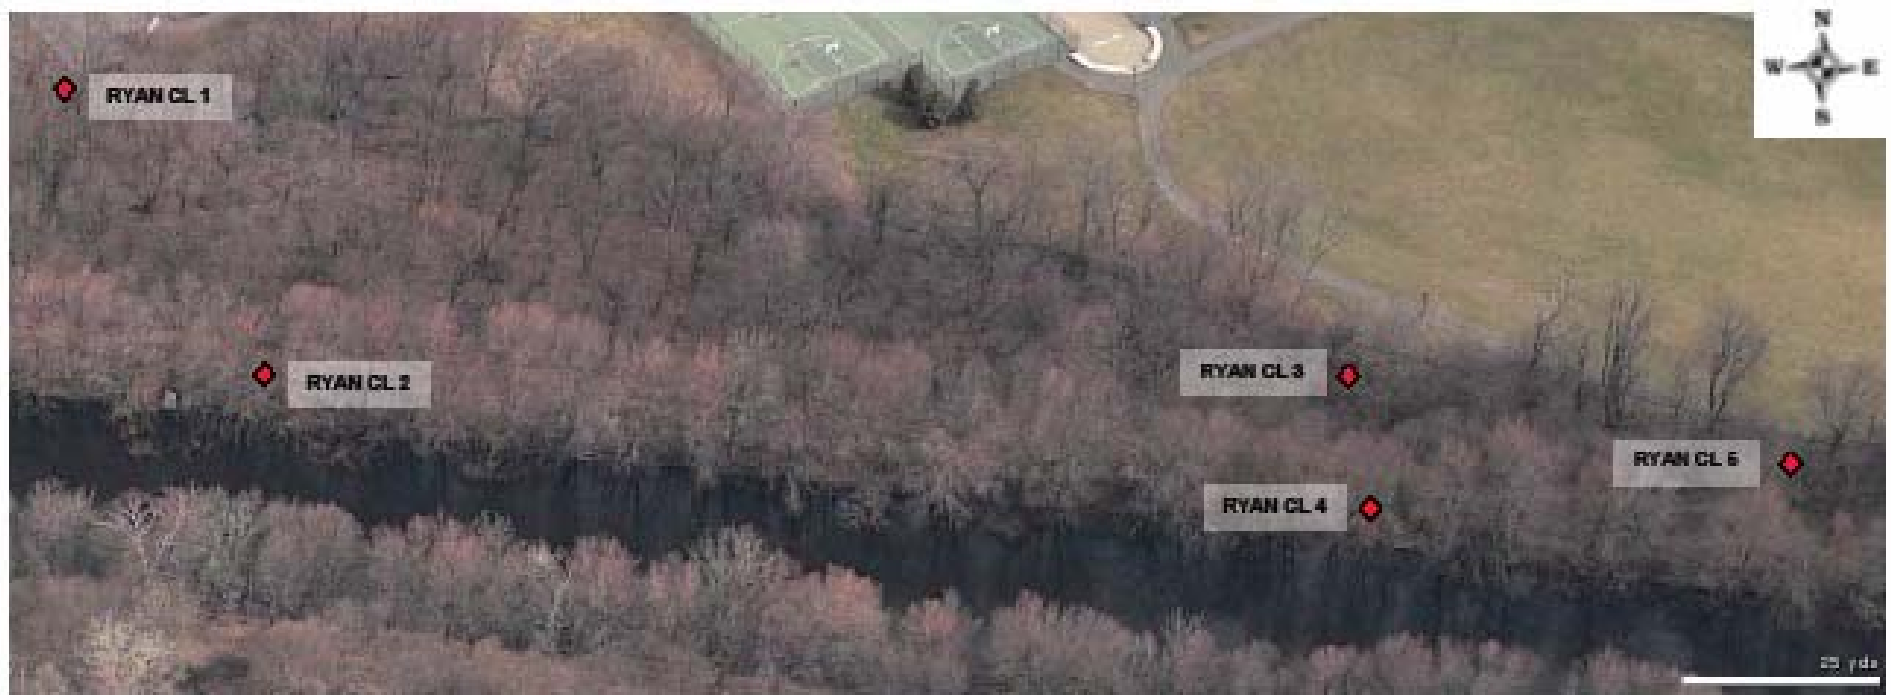
FIGURE 1
Spoil Area H
Surface Soil Sampling Locations
310 River Street, Mattapan, MA
May 3, 2007

Note: Surface soil samples were collected between 0 and 12 inches.

- Five samples were collected from surface soils adjacent to Ryan Playground and canoe launches
- The samples were analyzed for PCBs and Metals.
- Low concentrations of PCBs, trivalent chromium and lead were detected.
- All results are below MassDEP standards indicating no health concern.

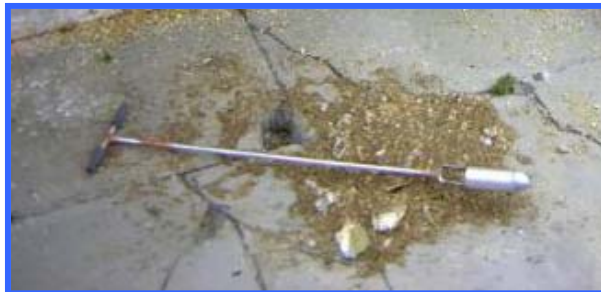
Sampling Procedures

- Sampling to be performed by hand with a soil auger and trowel.
- MassDEP or DCR representatives will be on-site to answer questions.
- Cones and caution tape will be used to isolate sampling locations.
- Excess soil will be returned to same sample location.
- GPS log of sample locations.
- Sample gear - Tyvek suits, gloves, hand auger, shovel, and trowel.
